Electrospark Deposition for the Repair of Army Main Battle Tank Components

ARL-TR-3849

July 2006

**Victor Champagne, Marc Pepi, and Brian Edwards
Weapons and Materials Research Directorate, ARL**

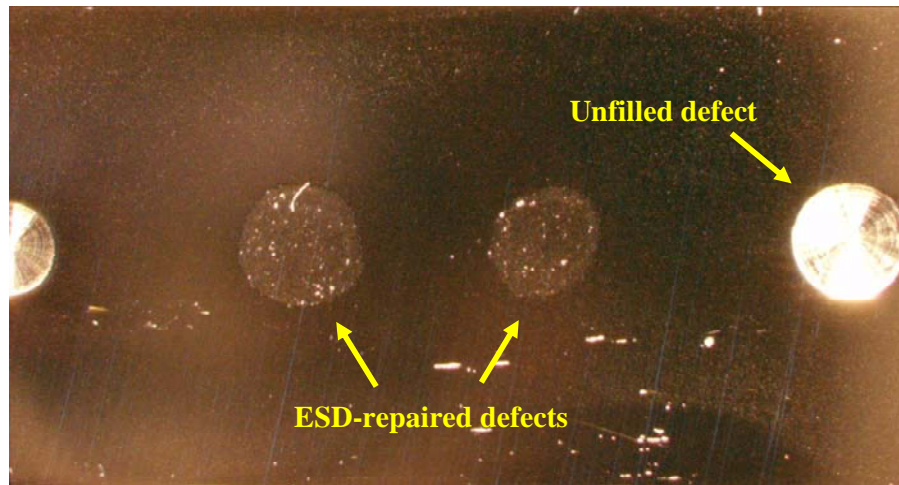
Figure 11. Optical macrograph showing two ESD-filled defects as well as one unfilled defect (magnified 2×).

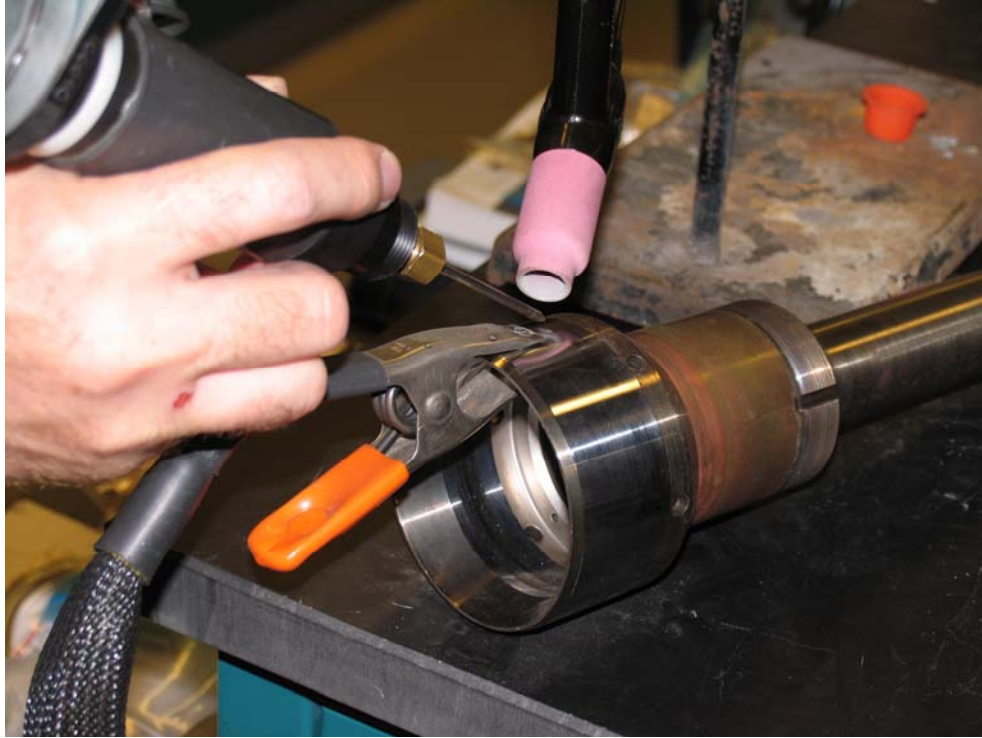
Figure 14. ESD being performed on an actual helical gear shaft containing defects at ARL.

Once these parameters were established, defects on actual helical gear shafts were repaired utilizing ESD (figure 14).

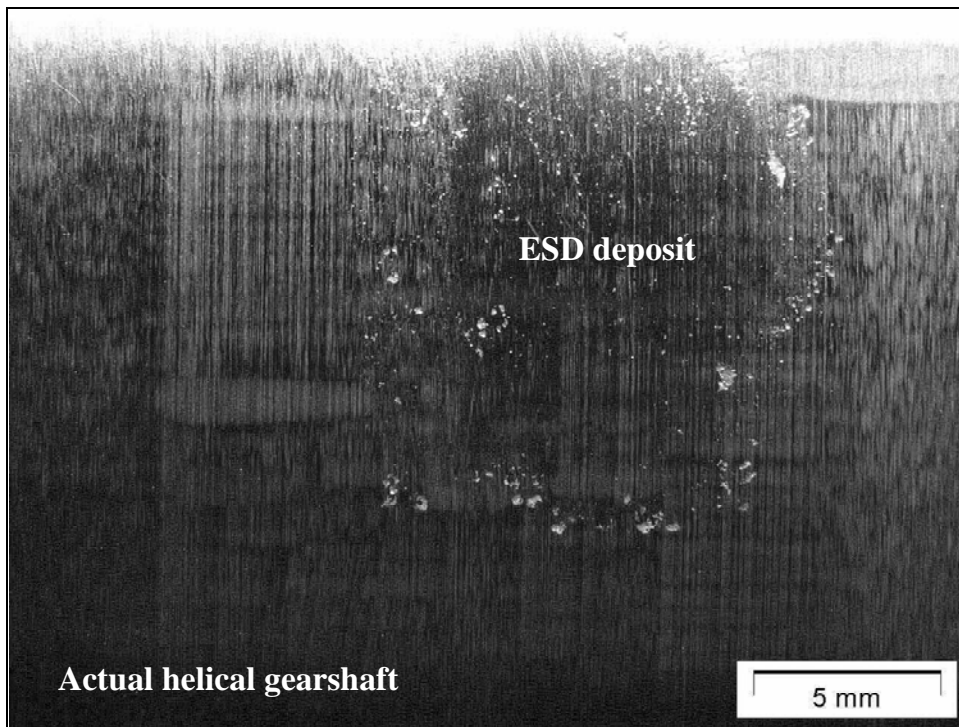
Figure 16. Porosity around the ESD deposit ("halo effect") of a chrome-plated sample (magnified 5 \times).

- ESD has been demonstrated to be a viable repair of corrosion pits and wear on both AISI 4130 and 9310 steels for use on nonrotating components.
- Caution must be taken when repairing chrome-plated components in order to reduce/eliminate the “halo effect.”

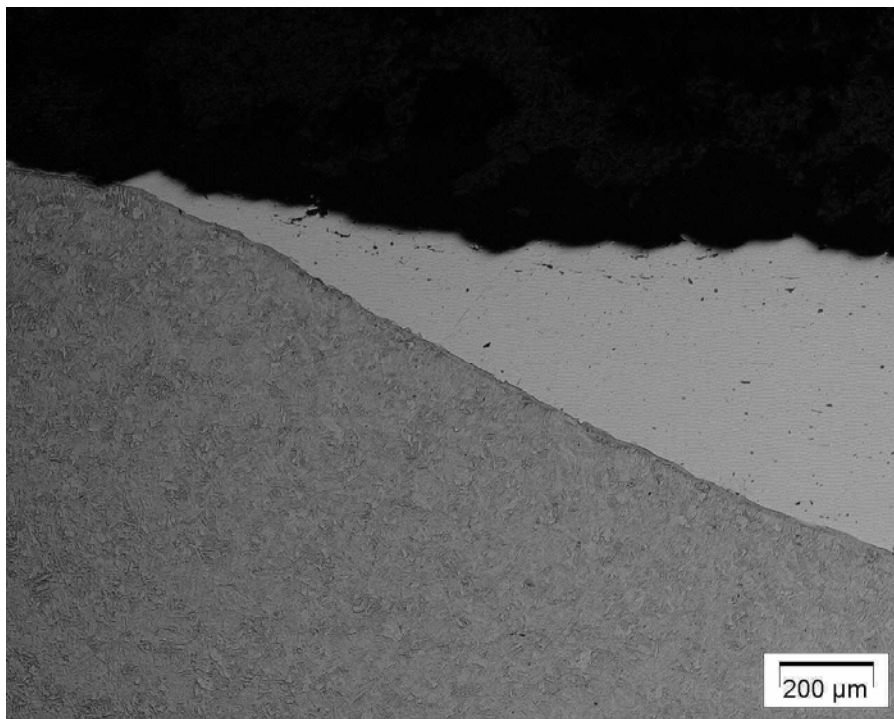
Figure 19. Polished sample cross section of an ESD-filled, chrome-plated defect showing no anomalies (magnified 200×).

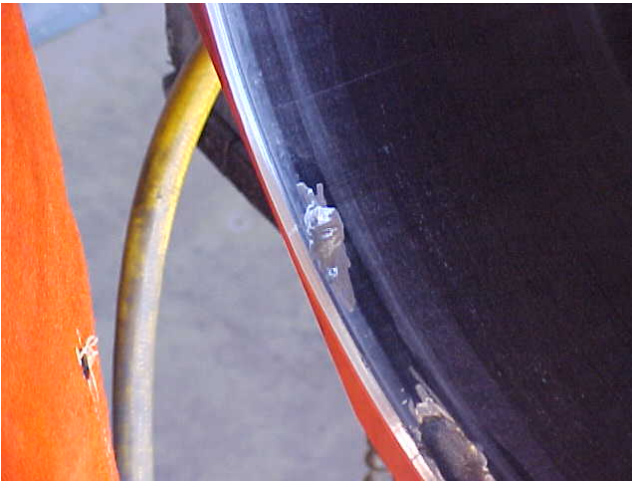
PITS PREPARED FOR ESD REPAIR

- a. Clean cradle using vapor degreaser.
- b. Using hand-held grinder w/wire brush, remove corrosion from pit.
- c. Using hand-held grinder w/grinding tool, break the sharp edges of the pit. If possible, maintain a width to depth ratio of 10:1 minimum to 20:1. The finish on the excavated defect should be in the 32-64 rms range for best ESD results.

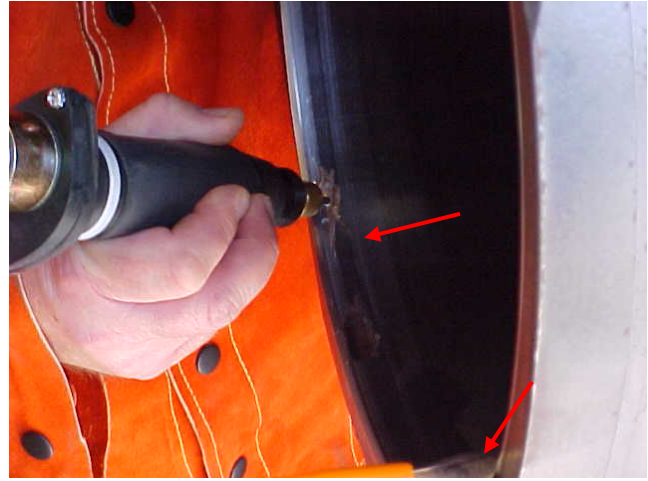
REPAIR PROCESS

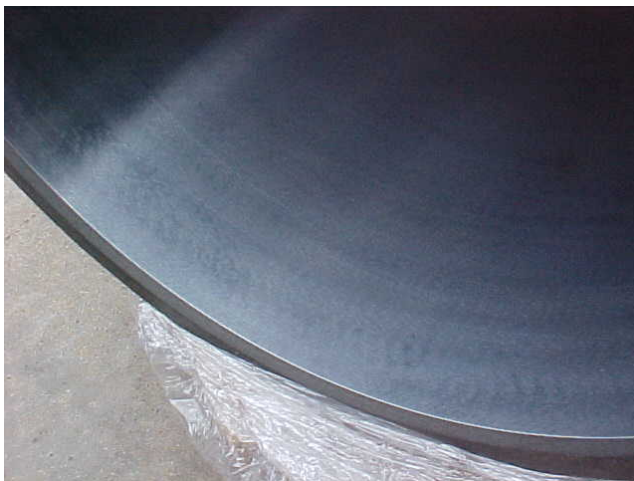
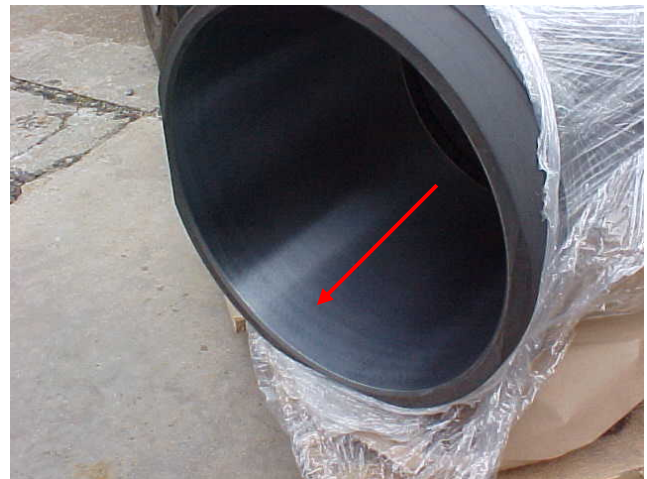
AFTER ESD REPAIR, CHROME PLATING, AND FINISH GRINDING

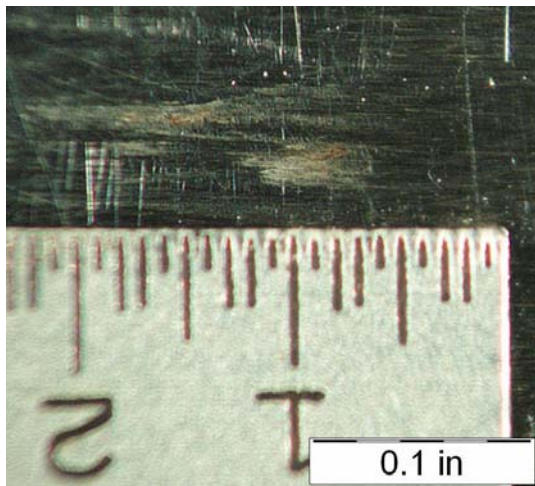
CORROSION PIT FOR ESD REPAIR

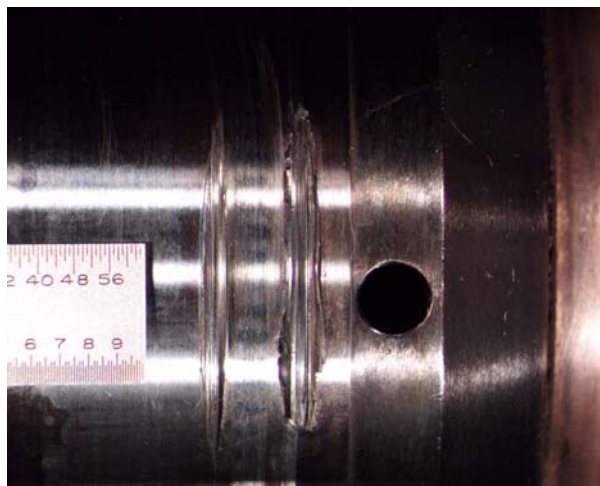
WEAR MARK FOR ESD REPAIR

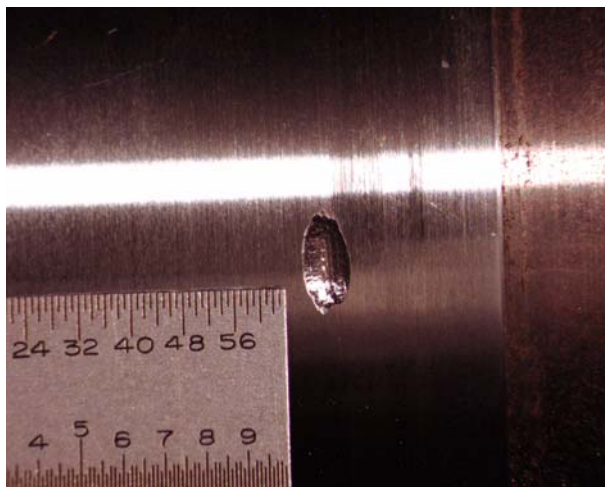
CORROSION PIT PREPARED FOR ESD

- d. Clean gear shaft using vapor degreaser.
- e. Using hand-held Dremel® tool (or equivalent), remove corrosion from pit.
- f. Using hand-held Dremel® tool (or equivalent), break the sharp edges of the pit or wear mark. If possible, maintain a width to depth ratio of 10:1 minimum to 20:1. The finish on the excavated defect should be in the 32-64 rms range for best ESD results.

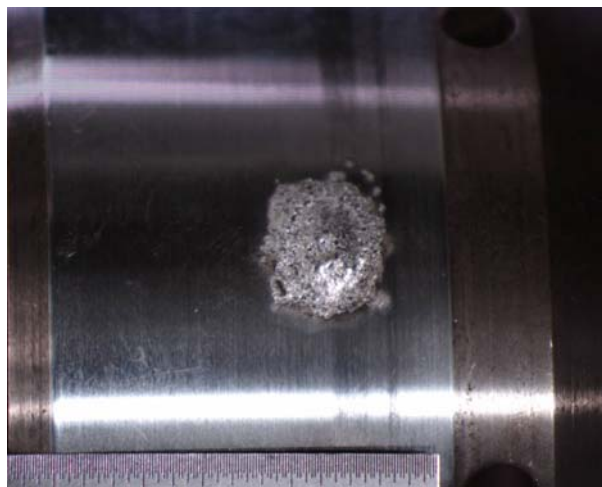
CORROSION PIT FILLED IN BY ESD

l. Using the ESD Equipment with the rotating torch (ASAP Model AH-98-MKIDD), the following settings/parameters and the electrode listed in paragraph 2c, fill the pit or wear mark to .005" - .010" above the parent material surface. This will ensure complete cleanup during grinding.

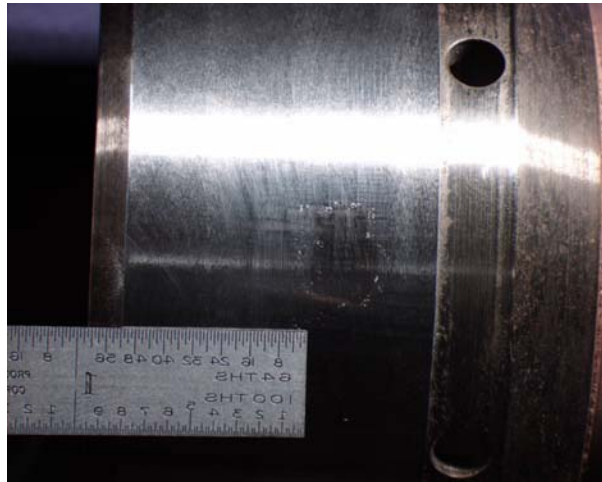
CORROSION PIT AFTER ESD REPAIR AND FINISH GRINDING
